dsPIC30F6011/6012/6013/6014

dsPIC30F6011/6012/6013/6014 Family Silicon Errata and Data Sheet Clarification

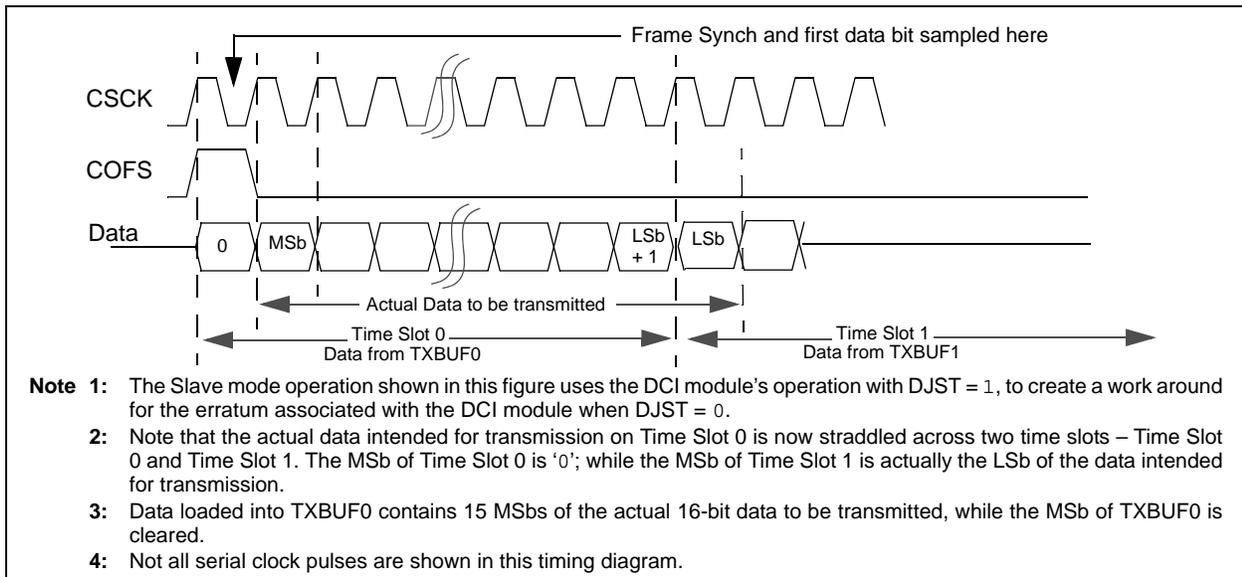
FIGURE 1: DCI SLAVE WORK AROUND

The Data Converter Interface (DCI) module does not function correctly in Slave mode when the following conditions are true:
