# MICROCHIP PIC18F2423/2523/4423/4523

## PIC18F2423/2523/4423/4523 Rev. B2 Silicon Errata

The PIC18F2423/2523/4423/4523 Rev. B2 parts you have received conform functionally to the Device Data Sheet (DS39755B), except for the anomalies described below. Any Data Sheet Clarification issues related to the PIC18F2423/2523/4423/4523 will be reported in a separate Data Sheet errata. Please check the Microchip web site for any existing issues.

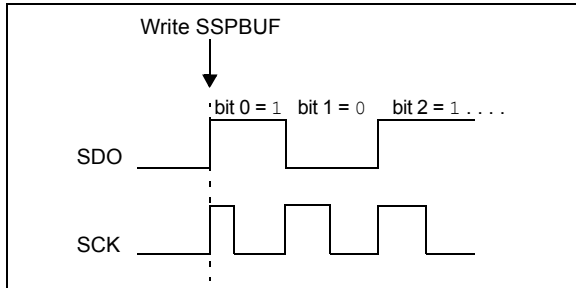
**FIGURE 1: SCK PULSE VARIATION USING TIMER2/2**

When the SPI is using Timer2/2 as the clock source, a shorter than expected SCK pulse may occur on the first bit of the transmitted/received data (Figure 1).

To avoid producing the short pulse, turn off Timer2 and clear the TMR2 register, load the SSPBUF with the data to transmit and then turn Timer2 back on. Refer to Example 2 for sample code.
